VOELCKER PARK

HISTORIC STRUCTURES REPORT

October 28, 2008

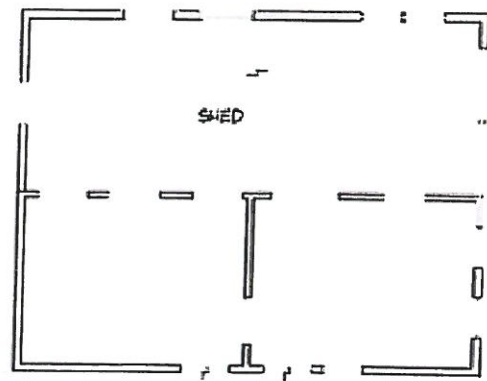
BREEZWAY

Comments: The breezeway floor is lower than the finish level of the milking barn and the two rooms to the east and therefore will have to be made and accessible. The majority of the windows will have to be restored or replaced but some of them can be salvaged. The building has to be treated for termite damage before any preservation work is performed.

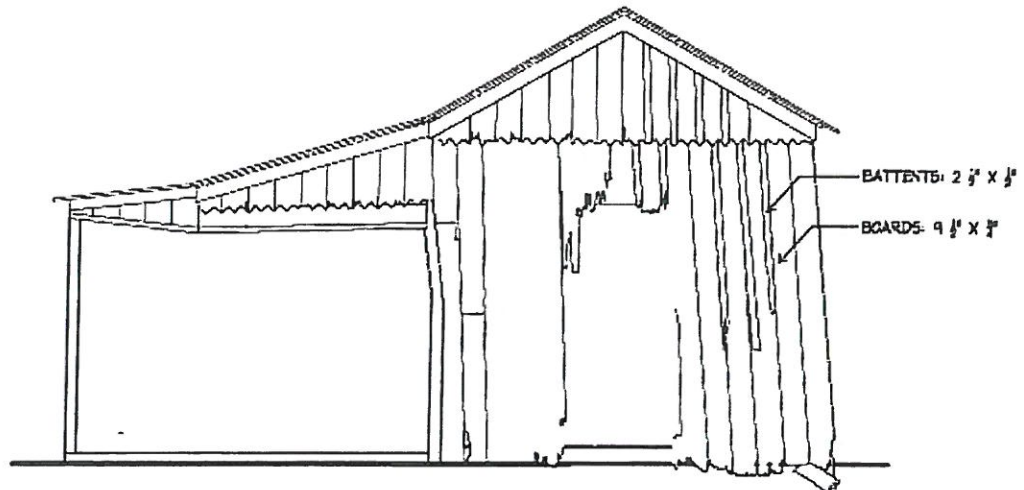
EAST ELEVATION

Comments: There is extreme termite damage to foundation, floors, roof framing, windows and doors. The foundation has failed and the growth of two oak trees has caused structural uplift on the floor and sideways thrusting on the walls.

Comments: This building needs to be reconstructed in order to preserve the essence of the farm complex.

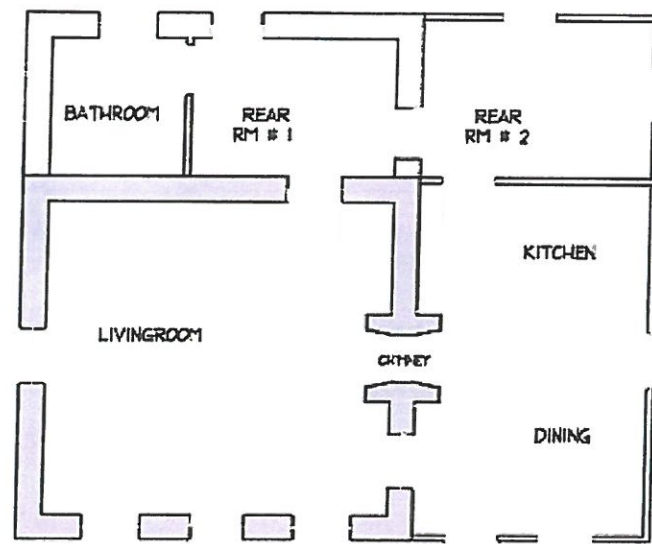
PORCH

Comments: All wood is painted – walls are white, ceiling is light green. Virtually all wooden elements will need to be replaced because of termite damage. There is a concrete floor in the two rear rooms on the north side of the house. Other floors are of 7" wood boards in extremely damaged condition. A masonry chimney serves both rooms at the front of the house. Rodents access the building through openings between the wall and roof structure.
